Chapter 5

Wetlands in River Valleys as an Effect of Fluvial Processes and Anthropopression

Abstract The aim of the article is to show how the fluvial processes in rivers and their valleys can support wetland restoration activities. The exemplary objects were localized in the Upper Vistula Basin (Poland) and dealt with riverbed stability, channel capacity as well as revitalization of rivers with their valleys regarding wetland restoration. All of the mentioned parameters depend on the intensity of fluvial processes in rivers, especially meandering, anastomosing or braided. Rivers always tend to reach the state of hydrodynamical balance reflecting the actual river dynamics. The nature of channel transformation is quite complex. For example, the curvature of natural river increases proportionally to the transported load alimentation and inversely to the slope of the river. The human-modified rivers also tend to increase the curvature of their channels. Interestingly, all rivers create wetlands in the areas naturally connected to the main channel. Those wetlands are regularly watered by flood events. As a result, the areas with wetlands are a perfect natural environment for fauna and

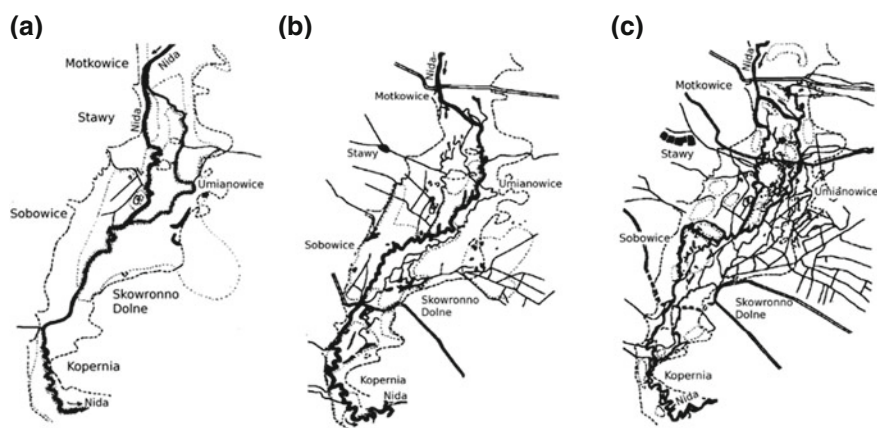
Fig. 5.1 Historical data show numerous changes of the Nida River morphology (after Łajczak 2006a). **a** 1839, **b** 1916, **c** 1938

Natural rivers modify their channels and valleys due to the fluvial processes appearing the whole year. The highest activity of the flowing water on channel creation appear with the quite low dominant flow which can be valued by the $Q_{75\%}$ (Leopold and Wolman 1957; Radecki-Pawlik 2011; Strużyński et al. 2013). These flows modify morphological parameters of the channel due to the bed and bank erosion or accumulation of bed material and contribute to the channel natural mobility (e.g., meandering, wandering) (Church 1992; Rosgen 1994). Dramatic channel transformations of river runs are very likely to occur during floods. According to the historical data gathered by Łajczak (2006b) on the Nida River, the multichannel system of lowland river can steadily change (Fig. 5.1).

Pictures describing the river system in the given years reveal the high hydro-morphological dynamics. Such an activity is frequently recorded in alluvial channels. Two mechanisms may appear in lowland rivers during floods. One is creating

new branches and cutting off the old channels and the other is cutting off the meanders and creating oxbow lakes. Between the active river channel and the old channels, wetlands, bogs or fens may occur.

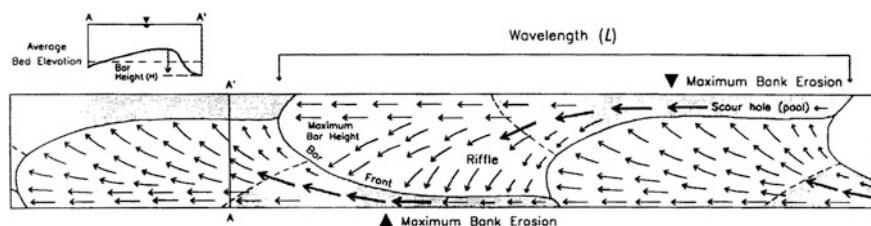
Fig. 5.2 The morphology of single-row alternate *bars* in straight channels with fortified banks (after Rhoads and Welford 1991)

The process of meandering initiation is well recognized and found often in regulated rivers (Leopold and Wolman 1960; Kitanidis and Kennedy 1984) (Fig. 5.2). The thalweg movement is connected with the secondary currents. The same tendency can be observed in straight, regulated channels.

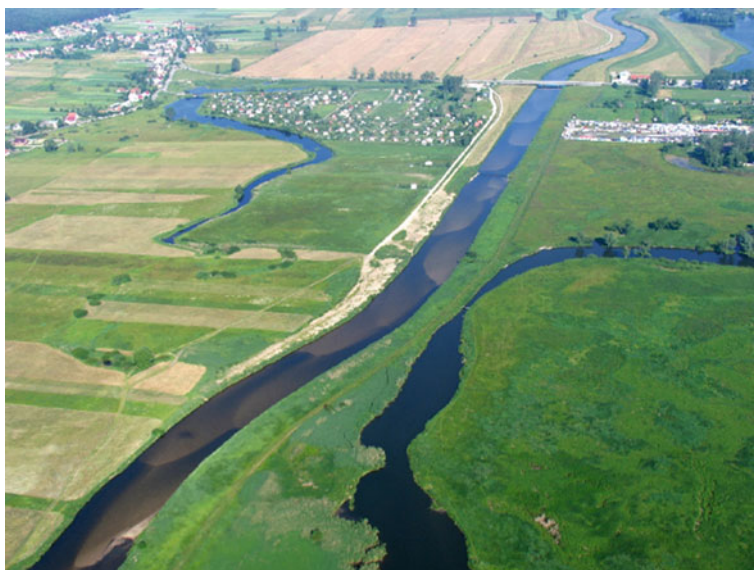
Fig. 5.3 Bedforms squeezed in a regulated channel (Source Pińczów Aero-club)

The aerial picture of the regulated lowland river, which is presented below, shows a distribution sand bars placed at an alternate angle (Fig. 5.3). This indicates non-homogeneous flow velocity distribution within the subsequent cross-sections. The presented riverbed forms move but sustain after frequent spring or summer floods. Regulated rivers are often separated from their valleys with the use of

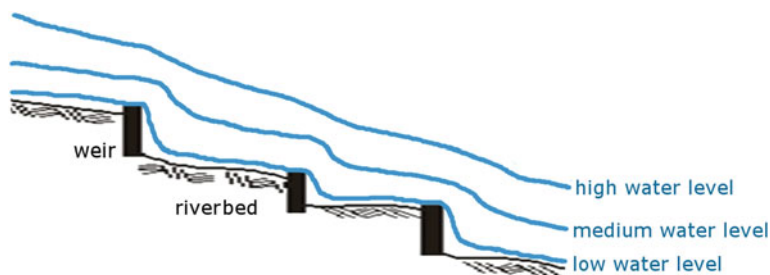
Fig. 5.4 The scheme of the regulated mountain river profile

As a result, the mountain rivers flow with a smaller slope in straight and slightly incised river channels (Fig. 5.4).

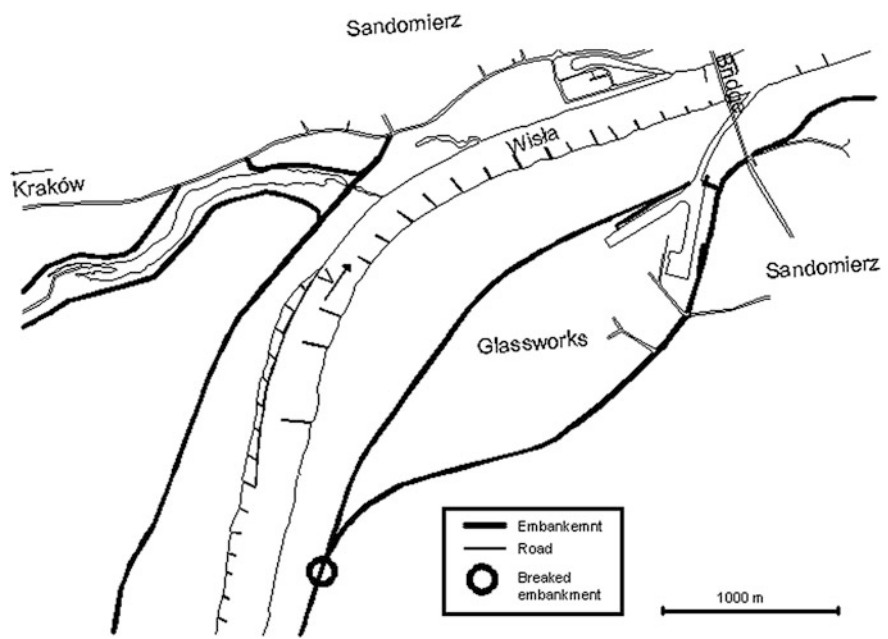
Fig. 5.5 Vistula River in the vicinity of the town Sandomierz

The Vistula River is planned to become a waterway. For this reason the reach near Sandomierz (Fig. 5.5) is embanked and regulated by groins. Flood corridor within

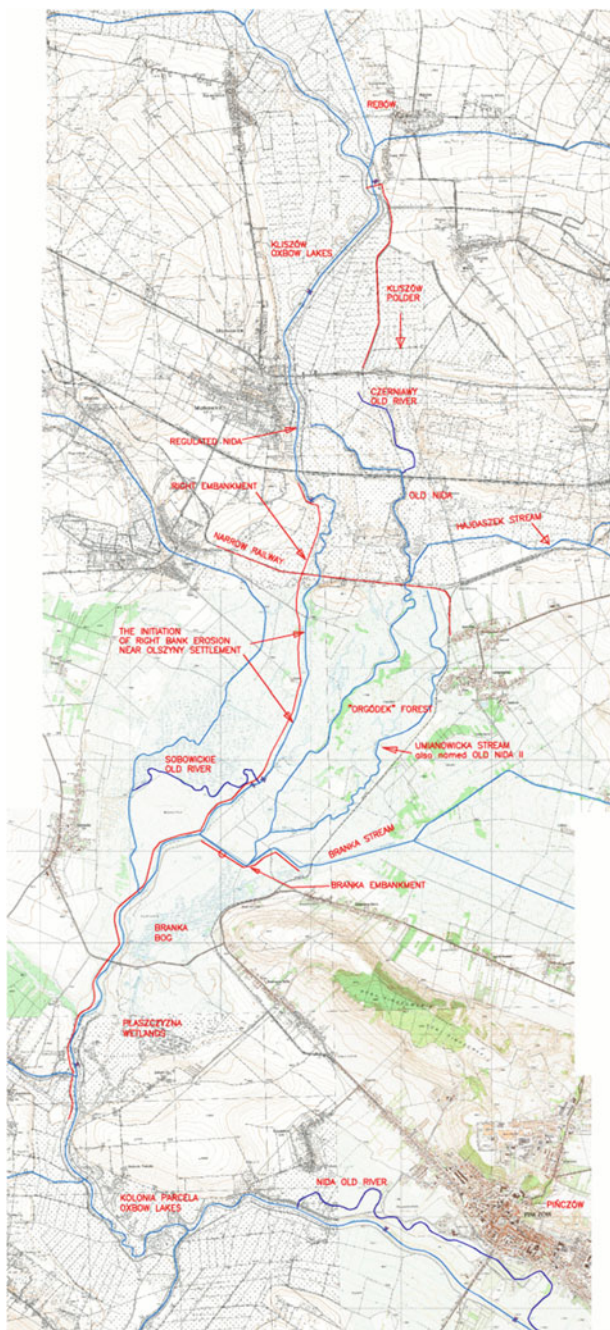
Fig. 5.6 The “middle delta” and its morphological objects

The investigated reach of the Nida River is located between the village of Rębów and the town of Pińczów. This lowland river—the left tributary of the Vistula River—can be predominantly regarded as close to nature. Flowing through the central part of Poland it had created in its middle run an “inland delta”, a unique multichannel system with numerous wetlands (Fig. 5.6).

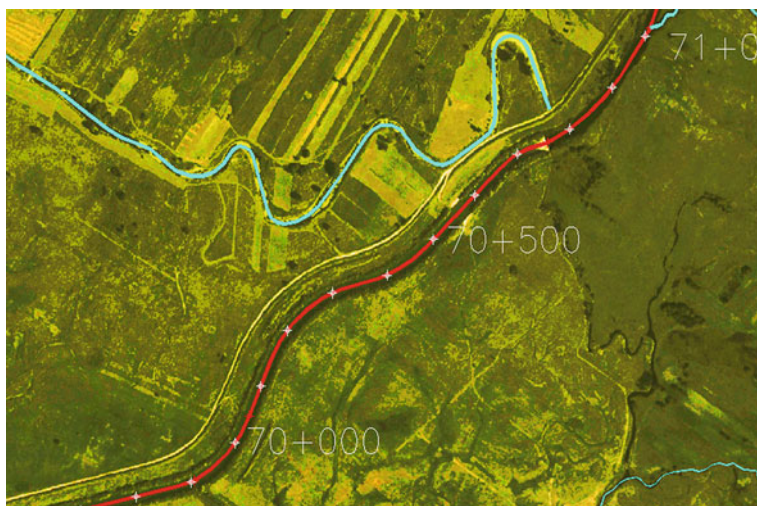
Fig. 5.7 The curvature comparison of the natural (*blue*) and regulated (*red*) river channel

transportation and instability of the bed during flood events. The curvature of the natural channel differs dramatically in comparison to the regulated ones (Fig. 5.7).

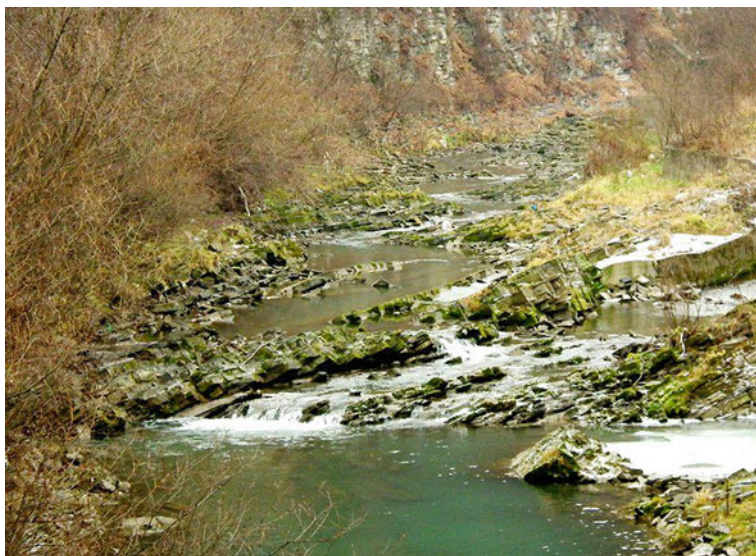
Fig. 5.8 Bedrock channel of the Porębianka River in the region of a local hydropower plant

to the RHS regulated reach, the rocky bed had been developed (Fig. 5.8) (Krzemień 1976, 1984; Radecki-Pawlik et al. 2010, 2013; Plesiński et al. 2013).

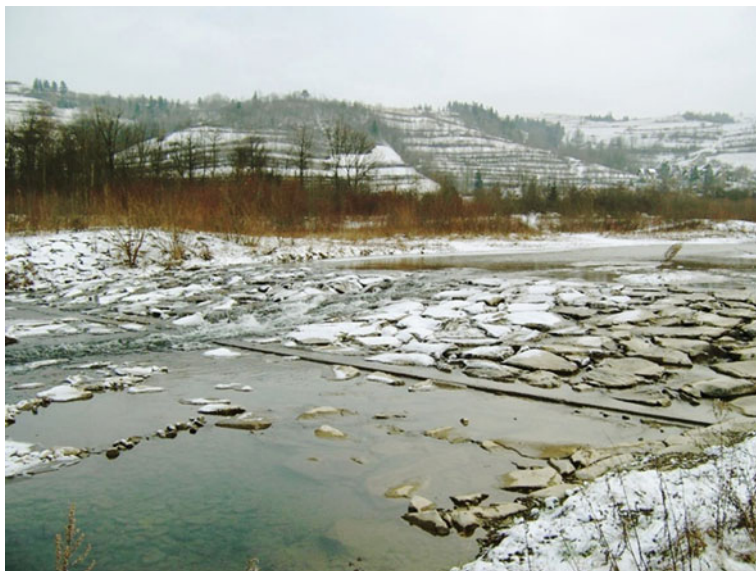
Fig. 5.9 Ramp—close to nature structure used in mountain rivers

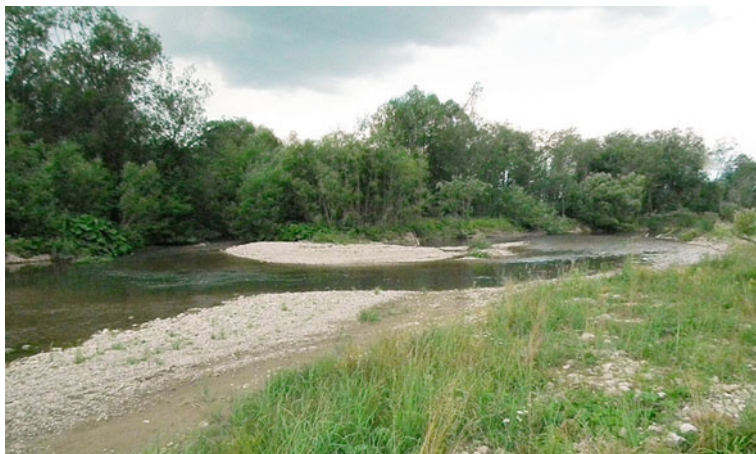
Fig. 5.10 The Czarny Dunajec River in the village of Wróblówka

Czarny Dunajec has its sources in the Tatra mountains. The river joins the Biały Dunajec River in the city of Nowy Targ, creating the Dunajec River. The flow dynamics of the Czarny Dunajec River is high. Nearly the whole area between the village of Podczerwone and the town of Nowy Targ is regulated with step correction and bank fortifications. Below the village of Wróblówka, there is only one, approximately 4 km-long segment of the river in which the channel is not regulated, preserving original character. In the highest two-and-a-half-kilometre-long reach the Czarny Dunajec River is braided and downstream it changes to island-braided (Wyżga et al. 2010b). In the above-mentioned part, the river creates complex bends which mark the migration zone of about 400 m width. There are numerous areas where the terrain is wetted as localized lower (Fig. 5.10). The whole valley is covered with abundant flora. Away from the course, in inundation terraces, there are fields used for agricultural purposes. The area of the river and the valley is protected

by:—South Małopolska Protected Landscape Area,—Nature 2,000 bird directive (Torfowiska Orawsko-Nowotarskie—PLB12,0007),—Nature 2,000 habitat directive (Torfowiska Orawsko-Nowotarskie—PLH120016).

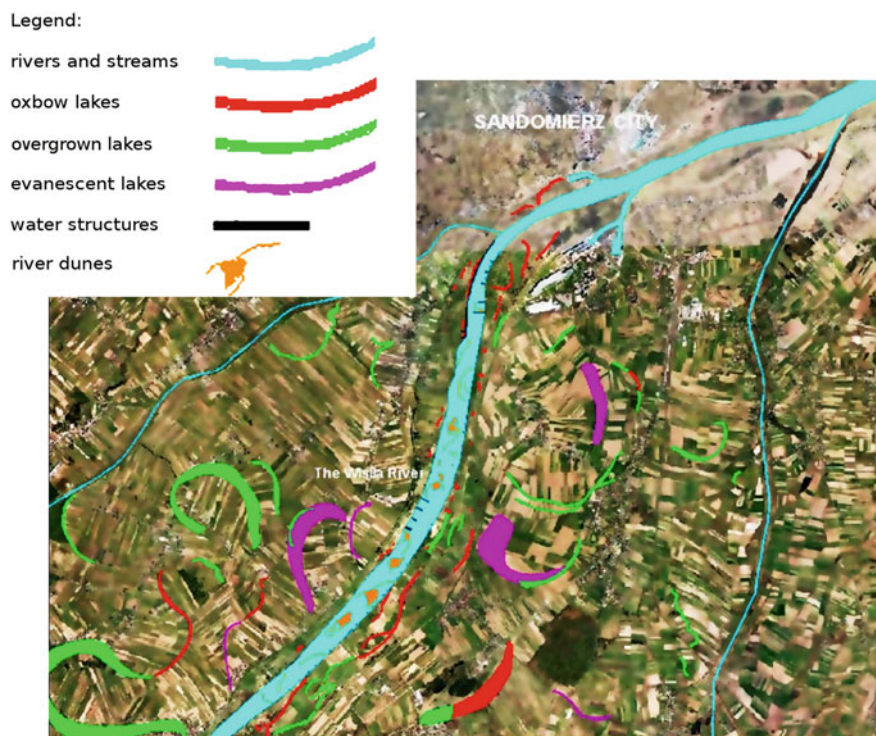
Fig. 5.11 Oxbow lakes and other channel-shape forms within the Vistula River natural migration zone (objects drawn on the satellite image. *Source* geoportal.gov.pl)

Presently no wetlands can be found in the valley of the **Vistula River** near Sandomierz (Łajczak 2006b), however numerous meander-shaped terrain forms remain there (Fig. 5.11). Terraces of Vistula river are made of muds and chernozems at a distance from 1 to 6 km from the river channel. This area used to be covered by wetlands. Upstream of Sandomierz, on both terraces, the oxbow lakes and the overgrown lakes exist. In Fig. 5.11 it is indicated that presently many of the well visible bars are forming, which indicates high fluvial activity within the channel of the Vistula River (Fig. 5.11, left—middle part of the picture). This shows that within this reach the transported material can settle outside the current.

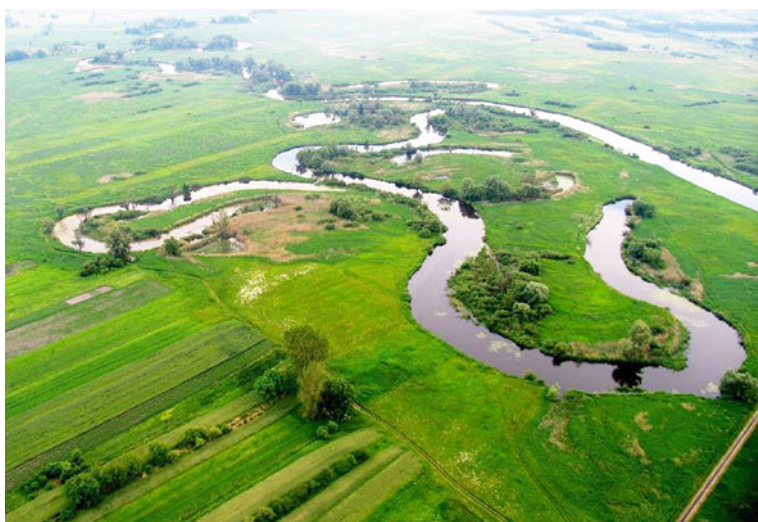
Fig. 5.12 Oxbow lakes surrounding the regulated reach of the Nida River in Pińczów (*photo* Aeroklub Pińczów)

At present, the **Nida River** is an example where natural and regulated channels can be found in the nearby area (Fig. 5.12). Currently there are two main old channels in the valley (Fig. 5.6). One is the Old Nida, and the other is the Umianowicka Stream

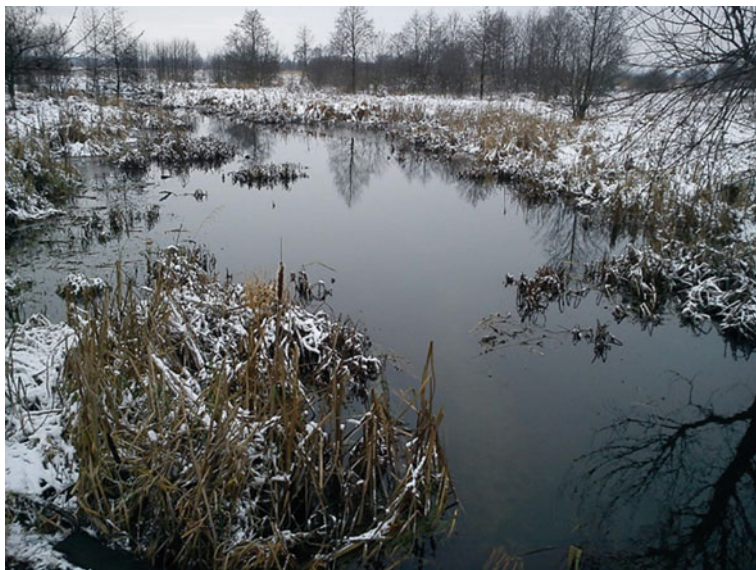
Fig. 5.13 The Nida's old river channel during winter

When planning renaturalisation projects in the "middle delta", it should be taken into consideration that there are still many rare species of fauna and flora living in the valley (Strużyński 2011). On the other hand, some parts of the river valley are still cultivated or used as grazing lands. Consequently, renaturalisation projects should deal with all of the mentioned problems, i.e.: take into account the safety of the passing floods, increase the riverbed stability, restore natural flow conditions in the regulated channel and in the old channels, as well as to improve the ecological state of the whole system (Bartnik et al. 2013). The work should start from redistribution of water flowing through the whole system existing in the "middle delta" (Fig. 5.13).

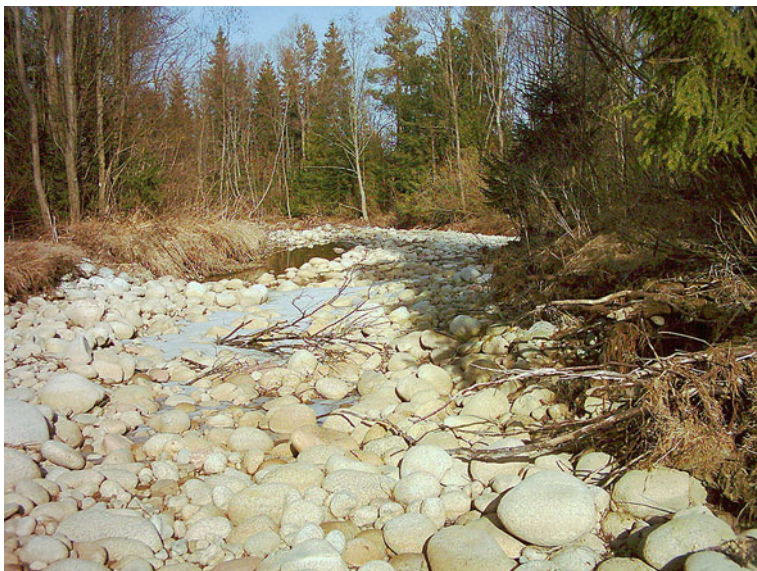
Fig. 5.14 Example of old channel “penetrating” the floodplain (Białka river)

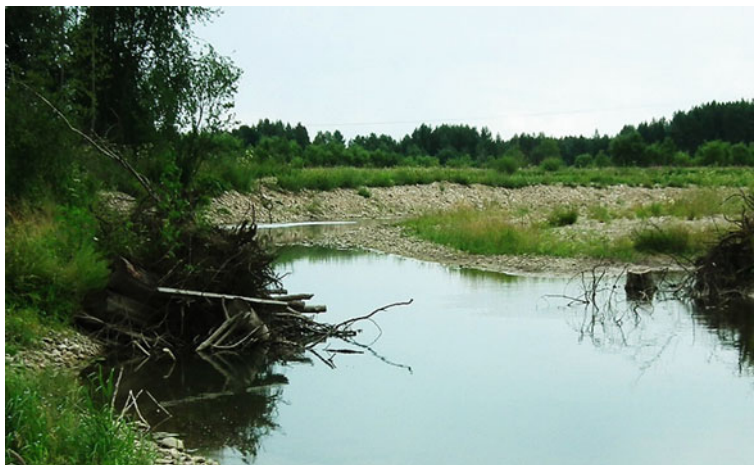
Fig. 5.15 The riverbed incision of the braided reach of the Czarny Dunajec

The **Czarny Dunajec** River within the mentioned reach flows between regulates sections. This influences the fluvial processes which transform the river from curvy to a braided river and closer to the town of Nowy Targ an island—braided channel. Through the braided part, the Nature 2,000 areas cross the valley from its left to the right side. Within the valley, multiple marks of the land-transformed oxbow lakes can be found. The incision of the riverbed exceeds 1.5 m (Fig. 5.15).

This signifies that erosion processes are still taking place, however the bedrock has not been reached yet and the braided character of the Czarny Dunajec River is still preserved. The main danger for this reach is the exploitation of the bed material
